Golden Gate Bridge Highway & Transportation District

Americans with Disabilities Act
Transition Plan

Sally Swanson Architects, Inc. 500 Sansome Street, Suite 410 San Francisco, CA 94111 Shao Chen, Project Manager

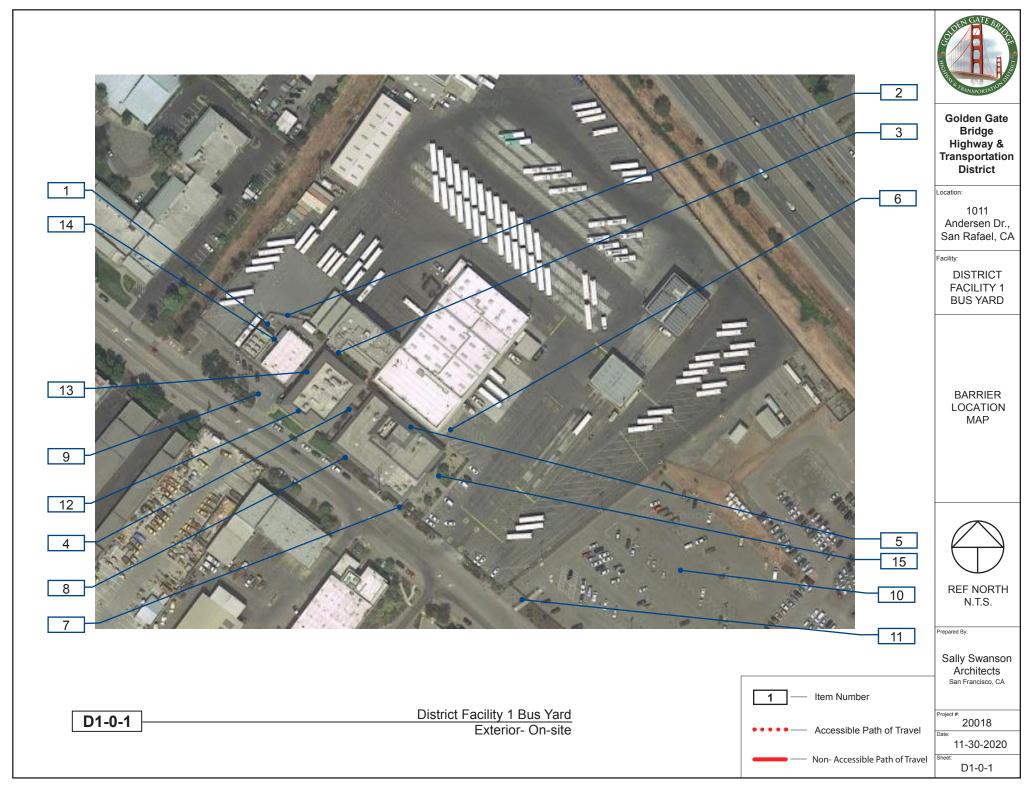
D1-0-1

The sidewalk has a highly irregular pavement surface due to excessive cracks and gaps along path of travel.

Remove, replace or repair area of pavement sufficient to correct abrupt change in level.

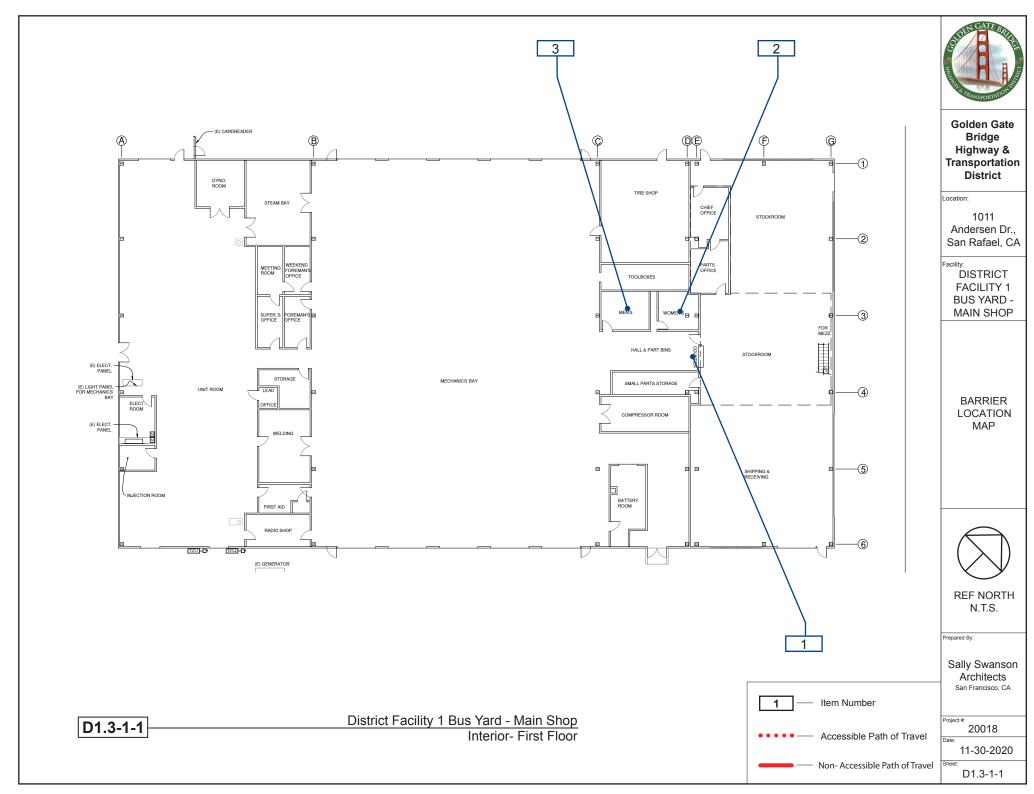
D1.3-1-1

Multiple accommodation restroom not accessible; multiple compliance violations.
